SUMMARY REPORT

FRP VESSEL

EQUIPMENT NAME:
Ferrous Storage Tank 3 South

EQUIPMENT NUMBER:
G-CST300-T35G2

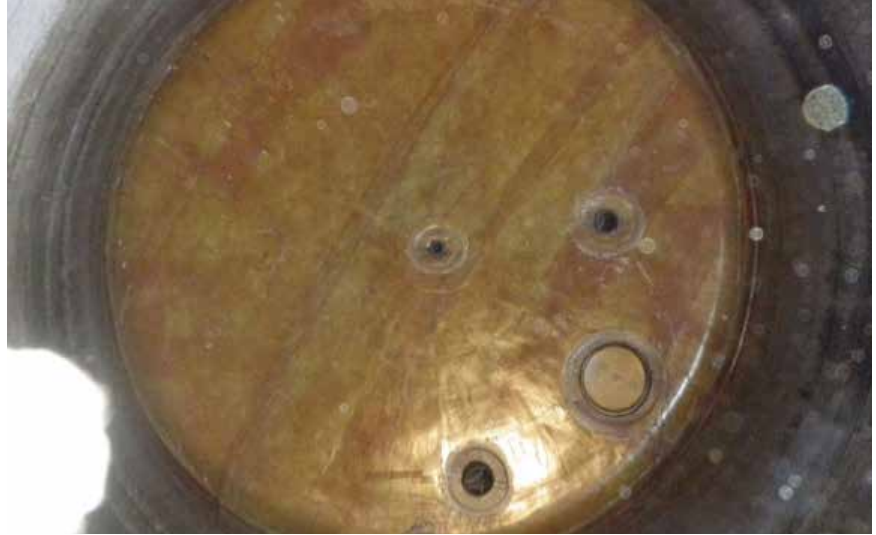
THE PHOTO OF THE ROOF OF THE TANK.

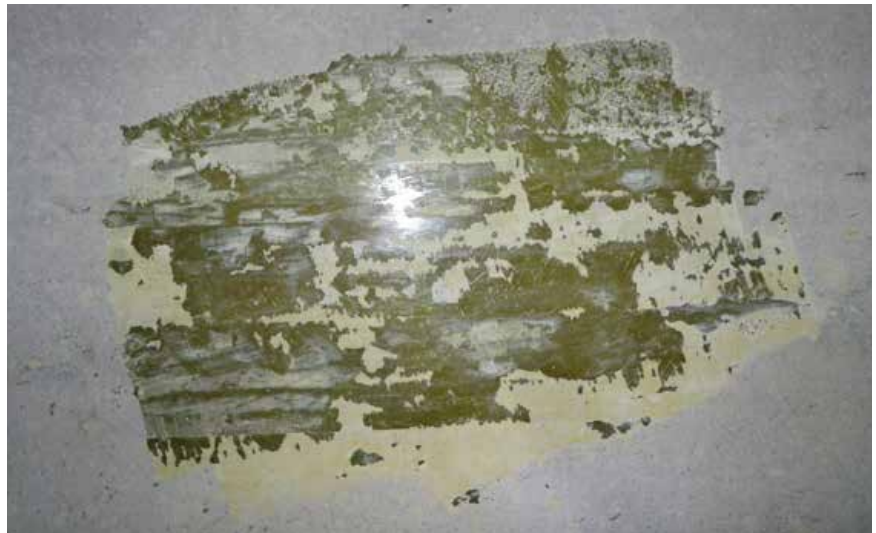
THE SHELL OF THE TANK IS COVERED IN A DRY POWDERY SUBSTANCE.

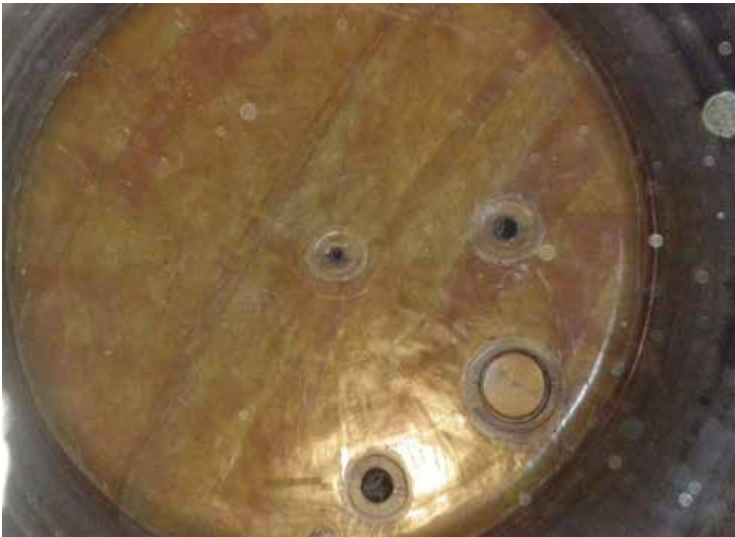
NOTES:
THE PHOTO OF THE ROOF
OF THE TANK.

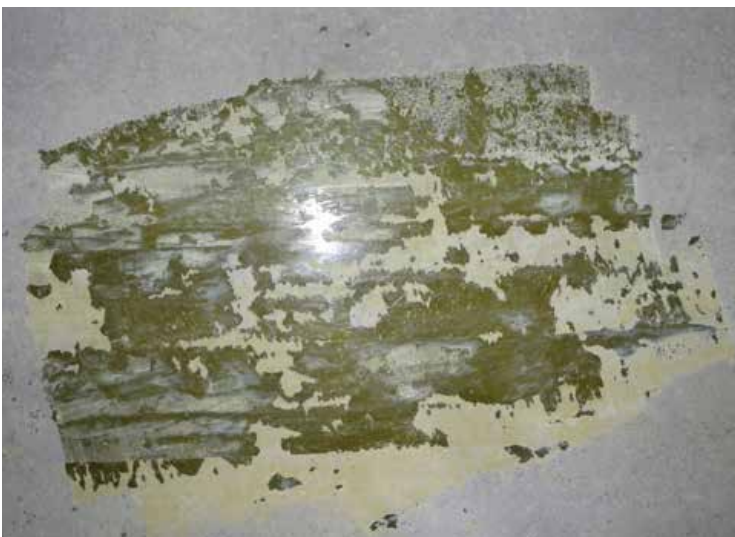
NOTES:
THE SHELL OF THE TANK
IS COVERED IN A DRY
POWDERY SUBSTANCE.
